# Manhole Inspection Summary

Manhole # S69U\_\_015MH

Insp Date: **5/21/08 2:43 PM**

**Location** Address: **1725 Malvern St.**

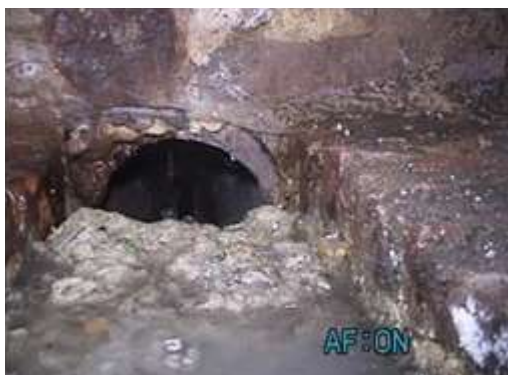
Defect 3

Comments **DEBRIS IN CHANNEL.**

Condition: ☐ Sound ☐ Cracked ☐ Root Intrusion ☐ Deteriorated ☐ Leaks ☒ Debris

heavy debris in channel

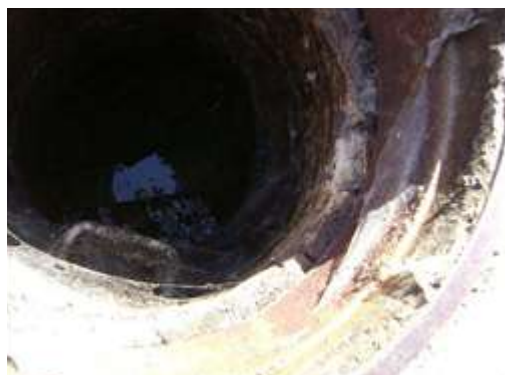
Defect 1

Condition: ☐ Sound ☐ Cracked ☐ Root Intrusion ☒ Loose Brick ☒ Deteriorated

missing mortar at frame adjustment

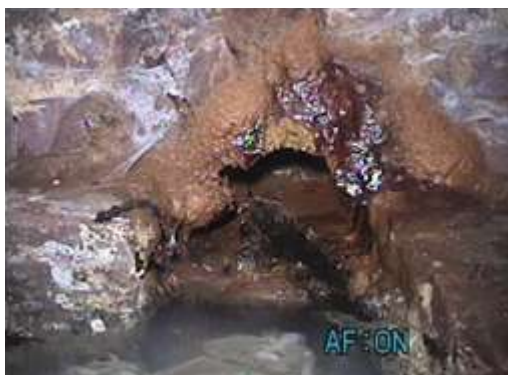
Defect 4

Infiltration: ☐ None ☐ Joint ☒ Cracks ☒ Mortar ☐ Roots ☐ Wall

infiltration on barrel wall above incoming 6 o'clock

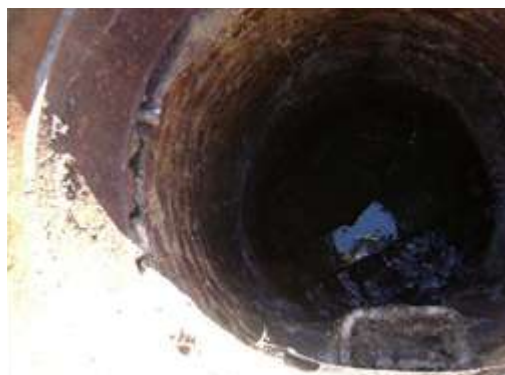
Defect 2

missing mortar and bricks at frame adjustment

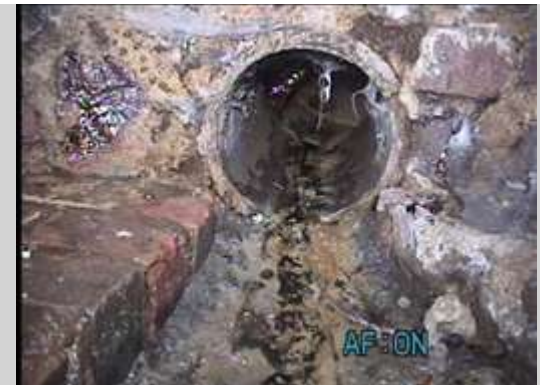
5 O'Clock Inflow

Pipe Height: **6** (in.) Rod and Bar (Angled)  
Pipe Material: **Clay** ☐ Pipe Lined  
Invert Depth: **8.08** (ft.) Flow Characteristics: **Slow**  
Deposits: ☐ None ☐ Mud ☒ ~~Gravy~~ ☐ Debris ☐ Grease  
Silt Depth: **0.125** (in.) Deposits Extent: **Light**  
Infiltration: **None** Pipe Seal Cond: **Sound**

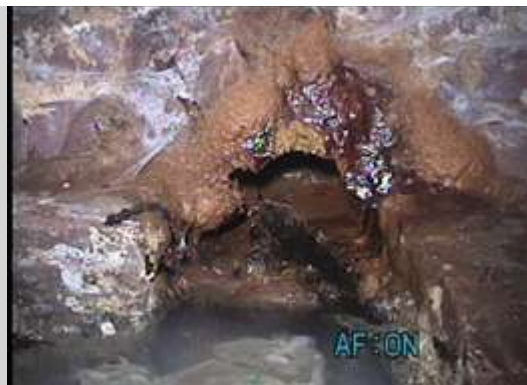
6 O'Clock Inflow

Deposits: ☐ None ☐ Mud ☒ **Sludge** ☐ Debris ☐ Grease

Silt Depth: **4** (in.) Deposits Extent: **Heavy**
